# Install Guide Front Upper A-Arms - Fixed Geometry Improvement

**Application** - Isuzu DMAX 2012-2020  
- Holden Colorado 2012-2020

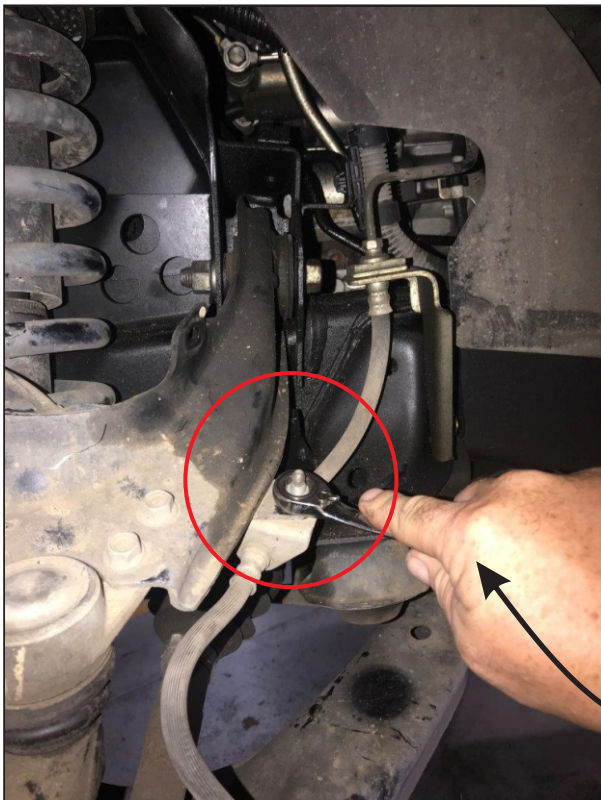
- Next, un-bolt the brake line.  
Refer LH image.

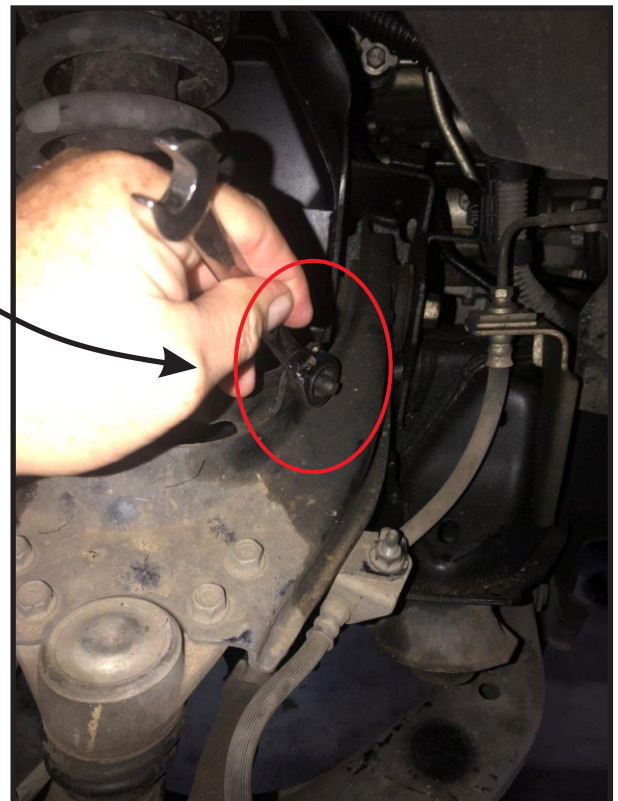
- Proceed to remove front wheels.
- Next, remove ABS sensor from the hub. Followed by un-bolting wire from the arm. Refer RH image.

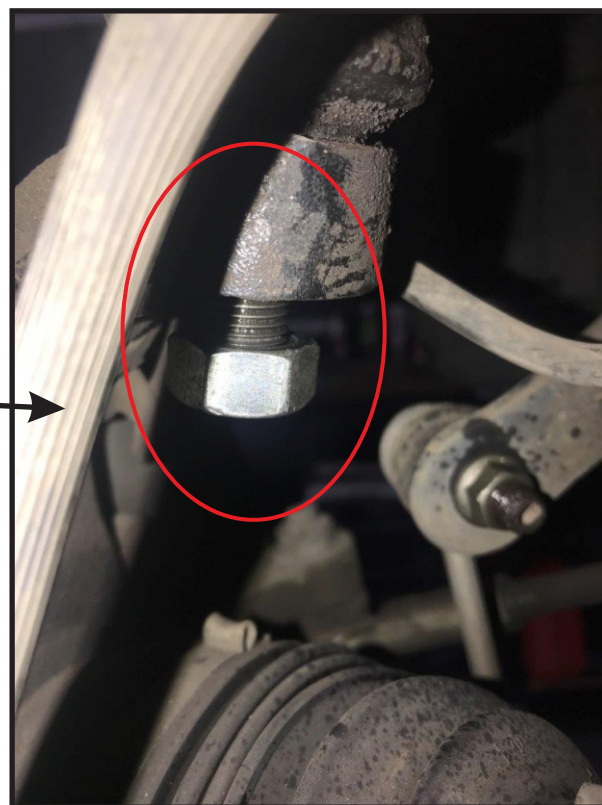
- Loosen and remove the 2 inner bushing bolts.

Refer LH image.

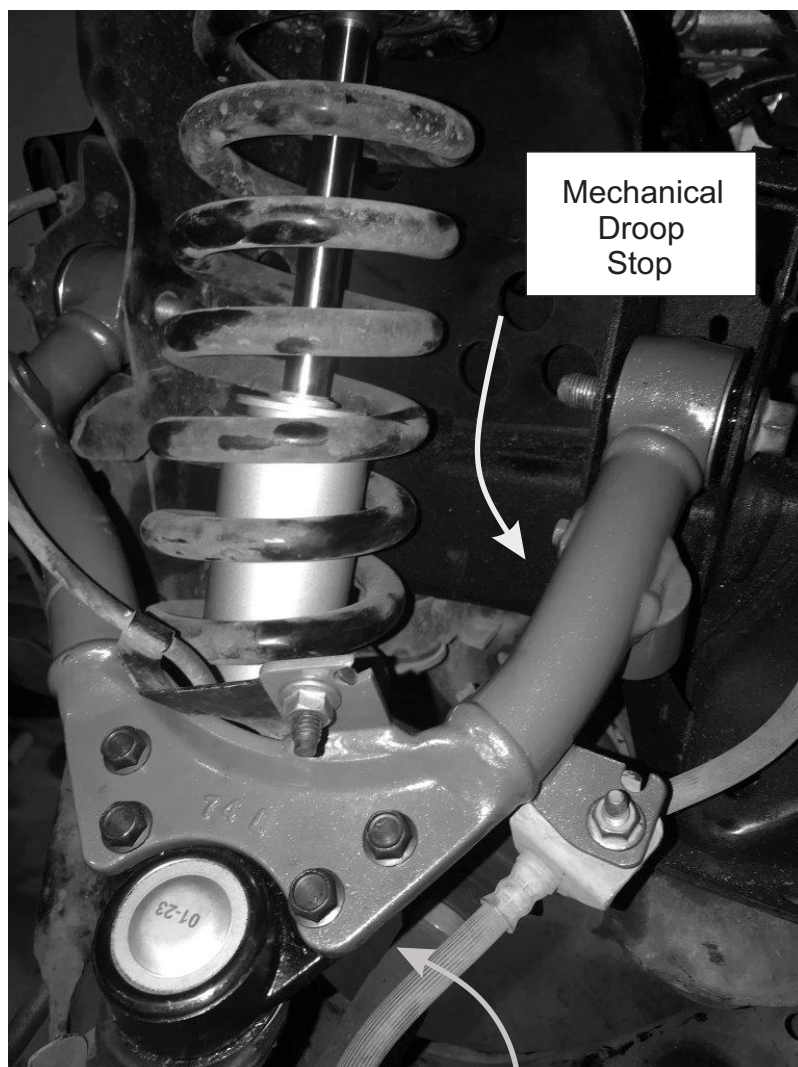
**Important - place ball joint under the arm as per below image.**

**LH A-Arm displayed above.  
Note - ball joint sitting under the arm.**
