Fitting Instructions #5696IS

Holden Rodeo TFR 2WD (1988-2003)

Front Upper Control Arm Inner Bush Kit

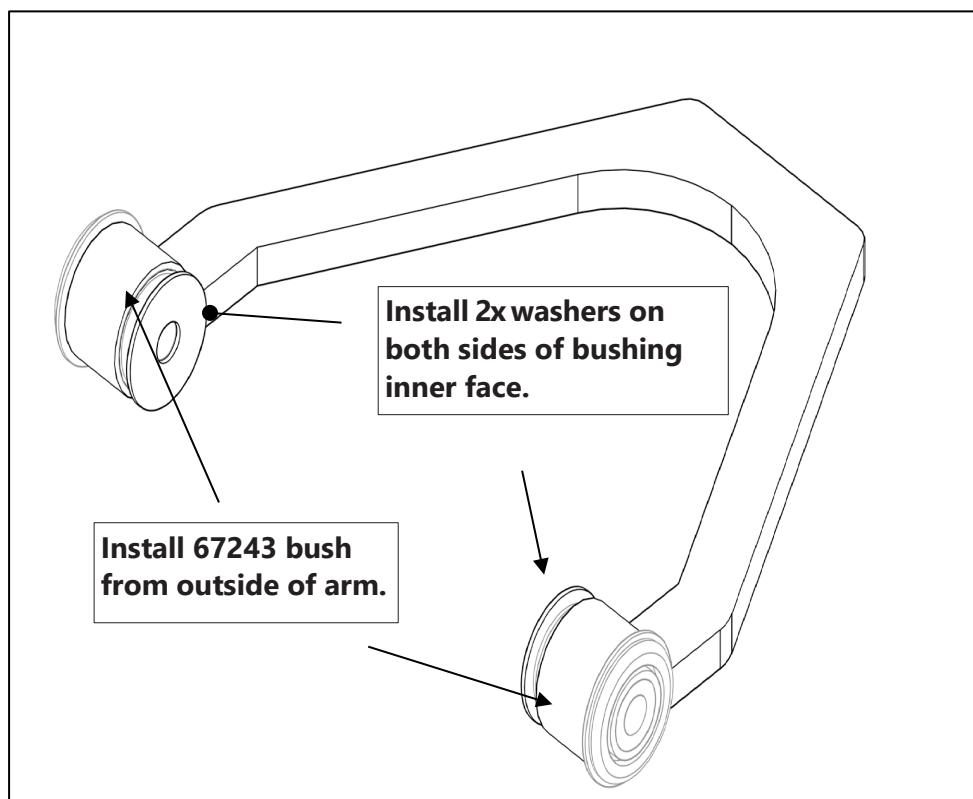
- Using the appropriate pressing tools support the control arm and press in the new bushes according to the orientation shown in figure below;
- Ensure to apply the supplied grease onto all mating surfaces;
- Refit the front upper control arms to the vehicle and tighten the bolts;
- Ensure that all fasteners are torque to manufacturer's specification and carry out a wheel alignment.

NOTE – Push supplied washer on (2x per side to seat against inside bushing face).
