Fitting Instructions #TRC6485IS

Toyota Landcruiser 200 Series

Front Upper Control Arms

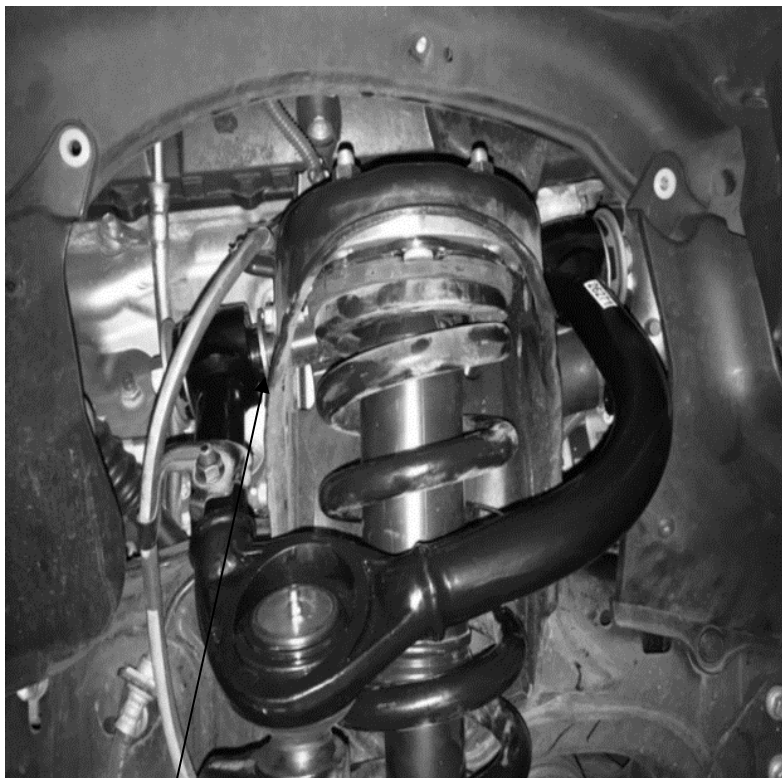
Figure 2 – Installed Arm

Insert supplied washers inside bushing face

8. Offer the control arm to the vehicle insert the bolt through the arm taking care to insert the supplied washers between the inside of the bushings and the spring tower.

9. Reuse the OE washer and nut thread onto bolt and Torque to 190 Nm. (See Figure 2)
