Fitting Instructions #5717IS

LDV D90 2017-on

Upper Trailing Arm Bushings

Superpro
Suspension Parts

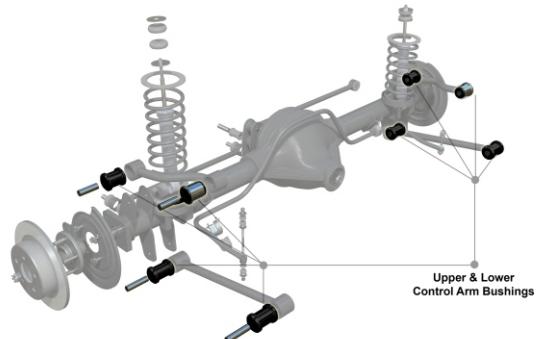
This bushing kit includes the following:

- Bushing 5717 x4
- Steel tube 24x14.3x52mm x4
- Grease

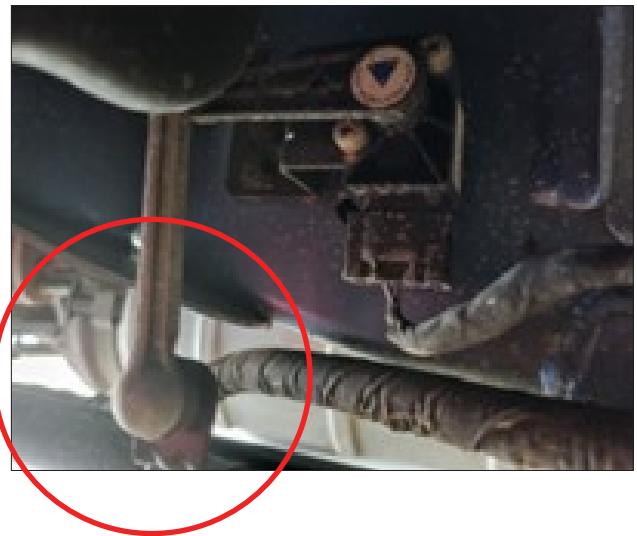
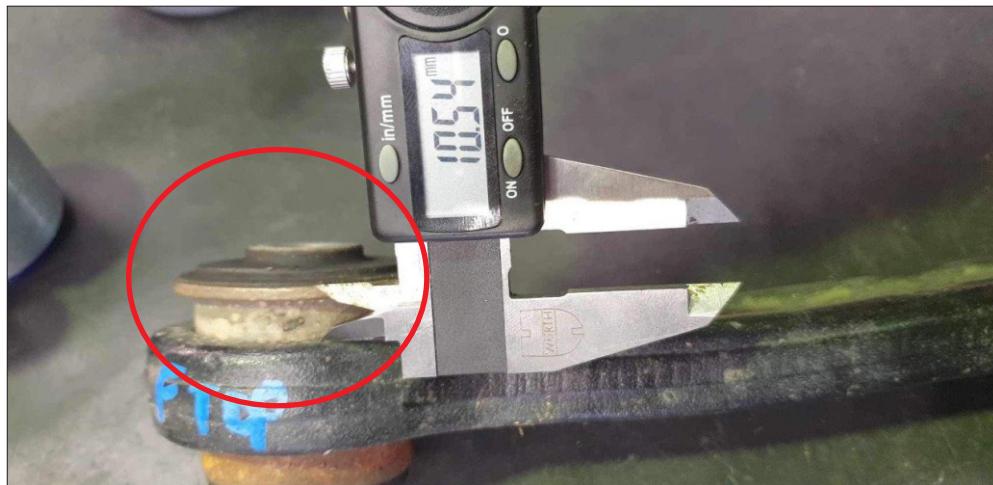
Note: if required, disconnect head-light sensor. Refer RH image. Careful not to damage the plastic lever. Refer page 2 for sensor re-positioning.

- Note the original bushing is pressed in the forged arm centrally. Note approx 10mm a side.
- Proceed to press bushing out (including steel outer shell).

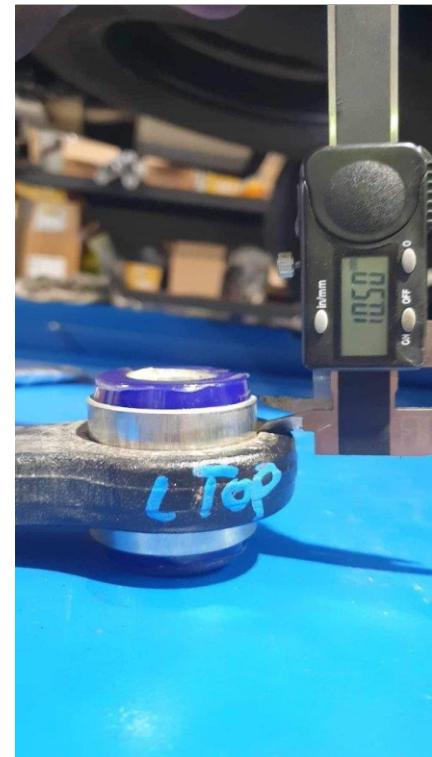
Pressing new bushing in:

- Once old bushings have been removed, clean the arm of any dirt, grease or burrs.
- Push new bushing **5717** into upper trailing arm. Using a small amount of grease on the shell can help with shell pressing. Remove excess grease after.

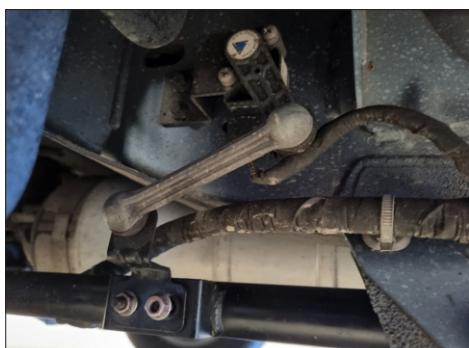
Incorrect Position

IMPORTANT: Check Head-light sensor position is correct. After removal of rear suspension items, the sensor may alter position and cause an incorrect headlight angle. Refer below images of INCORRECT and CORRECT position.
