Fitting Instructions #5718IS

LDV D90 2017-on

Rear Panhard Rod Bushings

Superpro
Suspension Parts

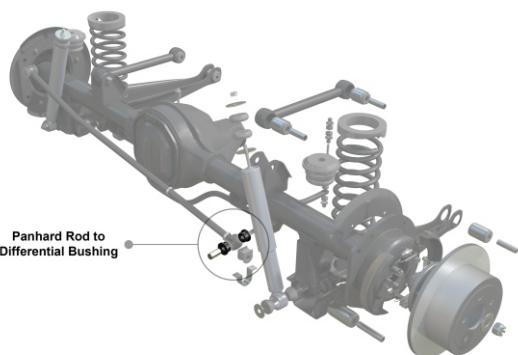
This bushing kit includes the following:

- Bushing 5718 x2
- Steel tube 24x14.3x52 x2
- Grease

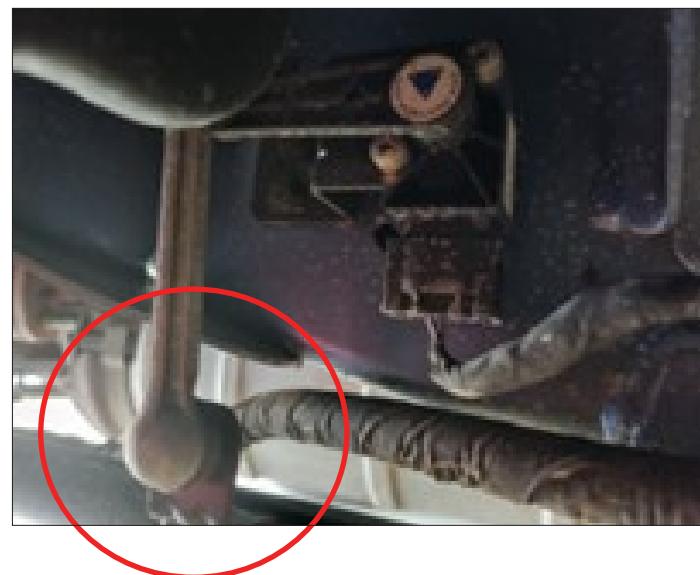
Note: It may be advantageous to disconnect head-light sensor. Refer below image.
Careful not to damage the plastic lever.

Refer page 2 for sensor re-positioning.

IMPORTANT: Check Head-light sensor position is correct. After removal of rear suspension items, the sensor may alter position and cause an incorrect headlight angle. Refer below images of INCORRECT and CORRECT position.

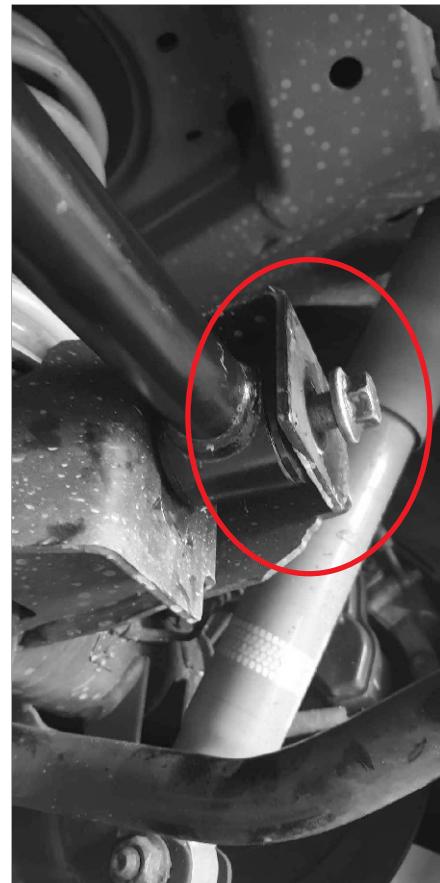
- Using a hydraulic press, press out the original bushing, including the steel shell.

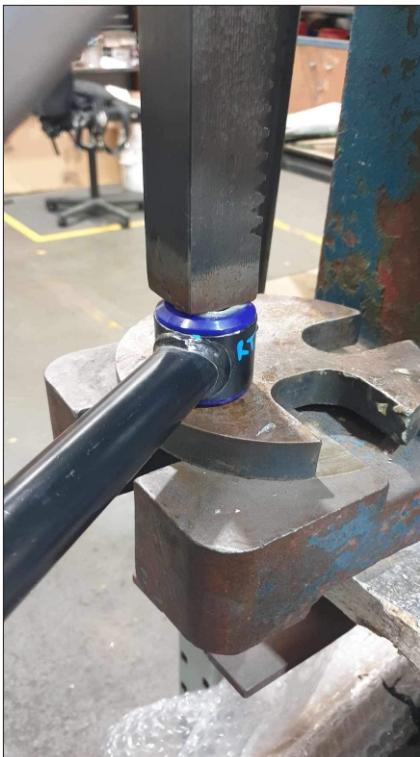
Pressing new bushing in:

- Once old bushings have been removed, clean the arm of any dirt, grease or burrs.
- Push new bushing **5718** into panhard rod. Using of soapy water and a solid press surface will aid with the install.

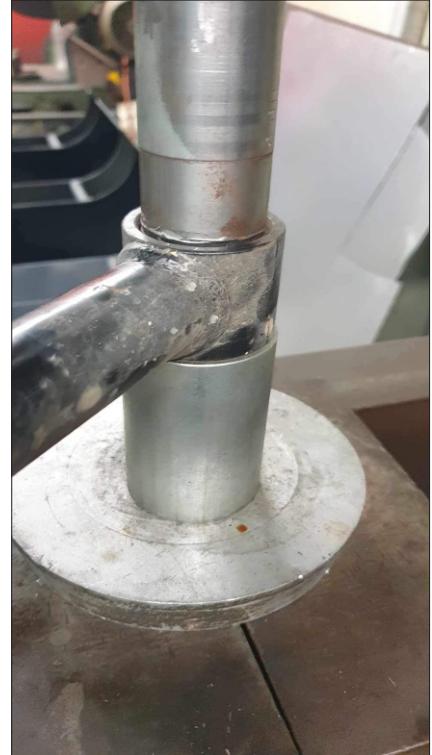
Pressing old bushing out:

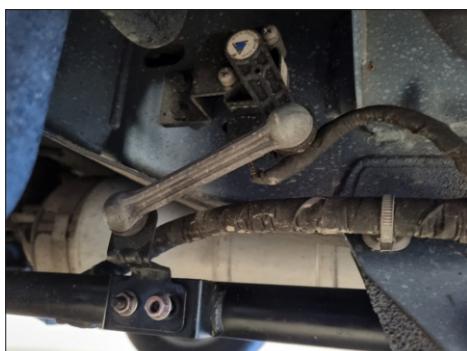
Incorrect Position

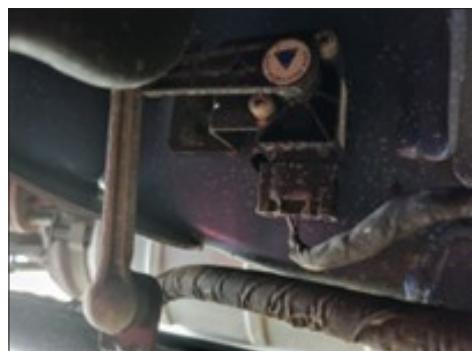
Correct Position (vertical)
