# Fitting Instructions #TRC6740IS

Toyota Tundra 2022+ / Sequoia 2023+  
*Fixed Offset Front Upper Control Arms*

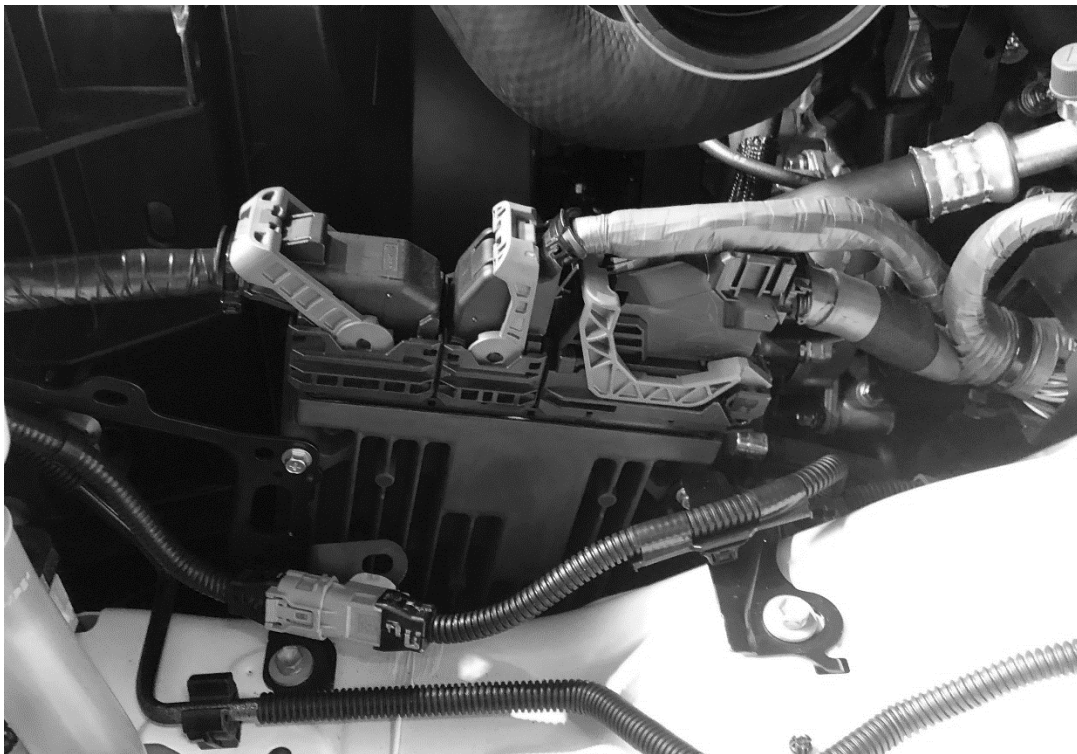
1. Raise the vehicle by the chassis and support on a hoist or on stands.
2. Start by disconnecting the battery before removing the airbox from the engine bay.
3. Once the airbox is out of the way, carefully remove the wiring loop from the ECU bracket before removing the ECU plugs and unbolting and removing the ECU.

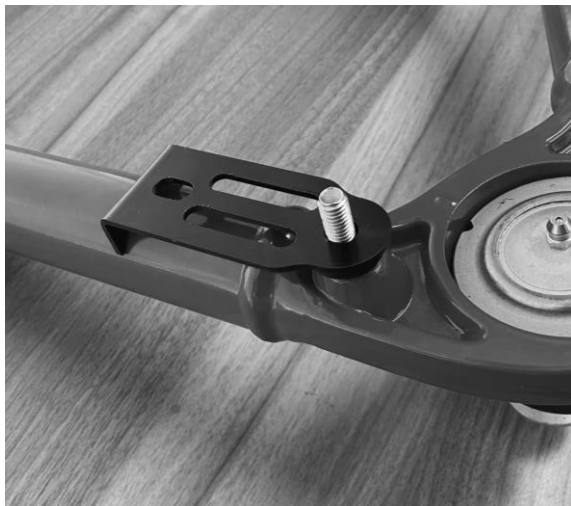
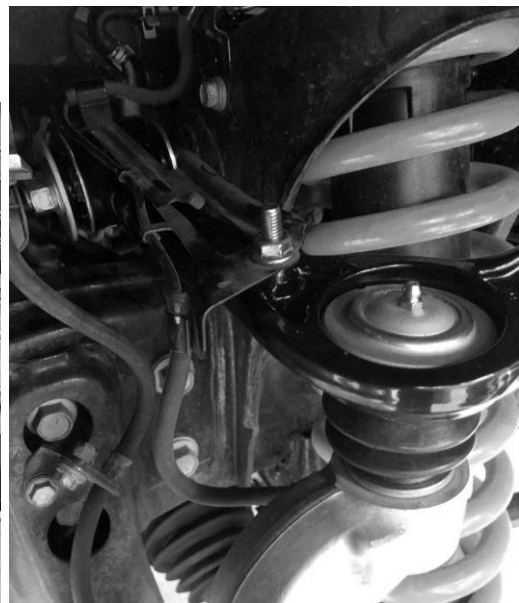
10. Bolt the new arm into the frame, reusing the factory bolt and place the supplied washers on the inside of the bushings. Torque to factory specifications
11. Install the stud of the ball joint into the upright.
12. Tighten the ball joint taper down using the new nut to factory specifications and install the new split pin or factory “R” clip.
13. Install the supplementary bracket onto the welded stud and arm.
14. Re-install the ABS sensor and attach the ABS bracket to the arm using the supplied nut.

15. Reinstall the headlight sensor bracket to the new arm if fitted.

**Note:** Check the ABS wiring to ensure that it is not under tension anywhere, some brackets may have been bent when the sensor and cable were removed.
