## MERCEDES-BENZ VITO W639 2010-on

### Front Control Arm Lower-Inner Front Bush Kit

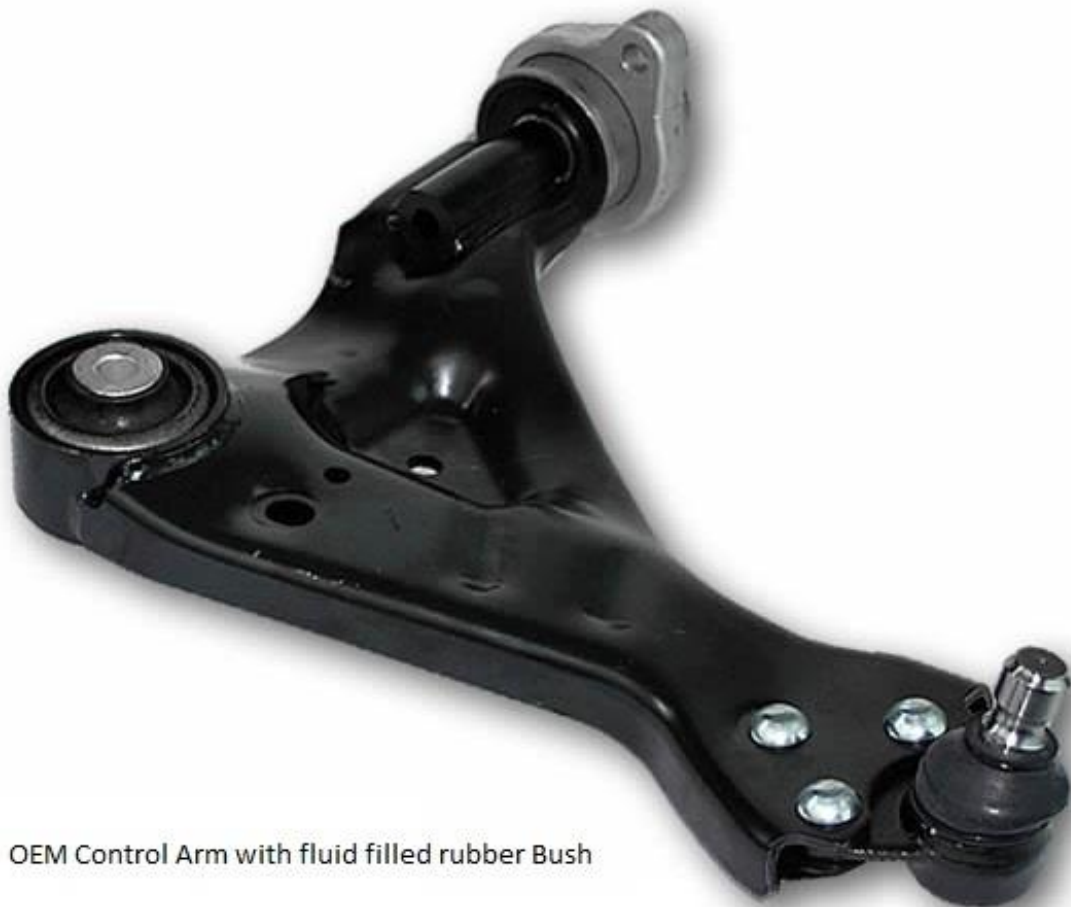
The O.E Original bushing is fluid filled for comfort however, the vehicle in Australian conditions is generally used in commercial applications on rough roads. Using our superior in house technology, time to market has been swift and we can now announce a new **SuperPro** part release allowing the highest users of this vehicle, fleets to have an economical repair to save down time.

OEM Control Arm with fluid filled rubber Bush

As these vehicles are predominantly used as commercial vehicles carrying high loads, all this excessive movement causes handling, braking and tyre wear issues.

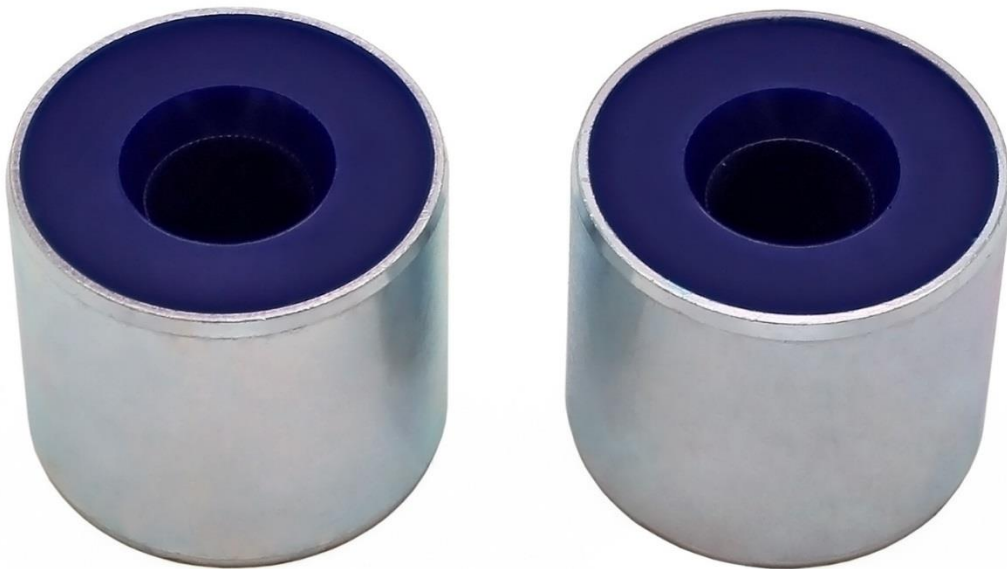
The **SuperPro** bushing kit **SPF4774K** is the perfect solution, durable, cost effective and available!

The **SuperPro** bushing kit is the perfect solution, durable, cost effective and available as a spare part only, not incorporated in a complete control arm as an expensive repair.
