**Application** - Mazda Miata Mx5 - 1989-2005

Contents - Bushing 2876A x2

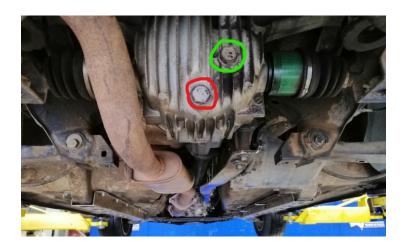
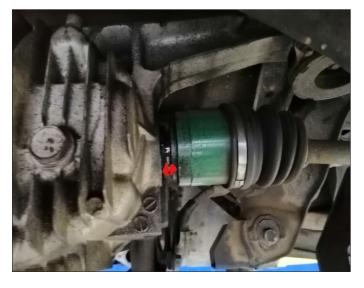
6. 'Pop' half shafts from retainers with pry bar.

See below image -

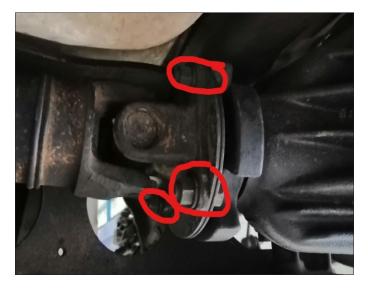
7. Remove 4 drive shaft bolts and remove drive shaft from vehicle.

See below image -

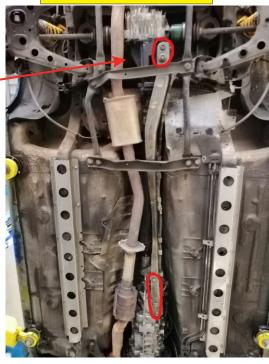
17. Now, the diff can be lowered while the drive shafts are removed. Careful to not damage the seals.

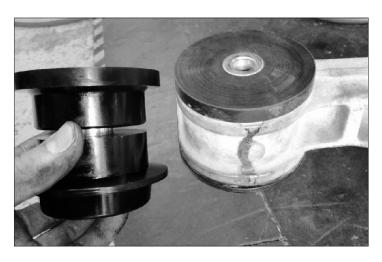
18. Below LH images shows the bushing orientation and situation in the diff housing.

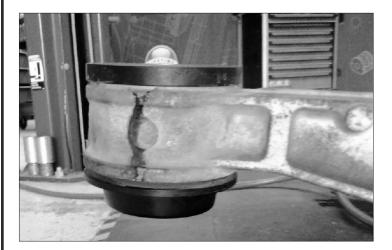
- 19. Remove the old rubber bushings from the aluminium housing. Careful to not damage the housing.
- 20. Pop in the new bushings as per the LH images.
- 21. Proceed to re-fit the diff to vehicle. When re-fastening the PPF, it should be supported to ensure it sits level and does not allow the diff nose or gearbox to sag. Failure to do so can cause excessive drive-line and body noise and vibration.

Also - careful with the driveshafts and seals
