Fitting Instructions #TRC6560IS

Ford Ranger – PX1,2,3/ Mazda BT50 2011 – 2020

Front Upper Control Arms

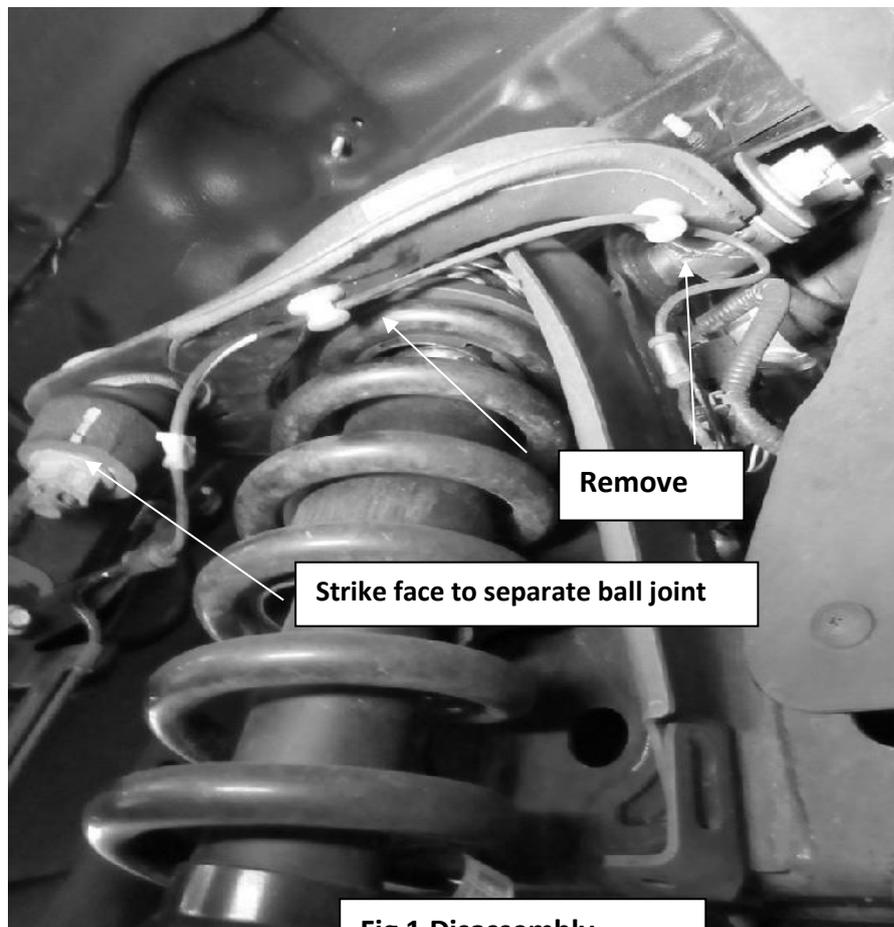
Fig 1 Disassembly

1. Before beginning any alignment work, always check for loose or worn parts, correct tyre pressures, and odd tyre wear patterns. Replace any loose or worn parts before setting alignment.
2. Raise vehicle by the chassis and support the lower control arm with jack stands. Remove front tyre and wheel assemblies;
3. Remove clips/bolts holding ABS wiring on upper arm, taking care to remove clips.
4. Remove split pin and nut from spindle
5. Break ball joint taper from spindle and support spindle so there is no strain on the ABS wiring and brake lines see **Fig 1**
6. Take note of the position of the OE washers remove the control arm mounting bolt and set a side
7. Remove arm and discard

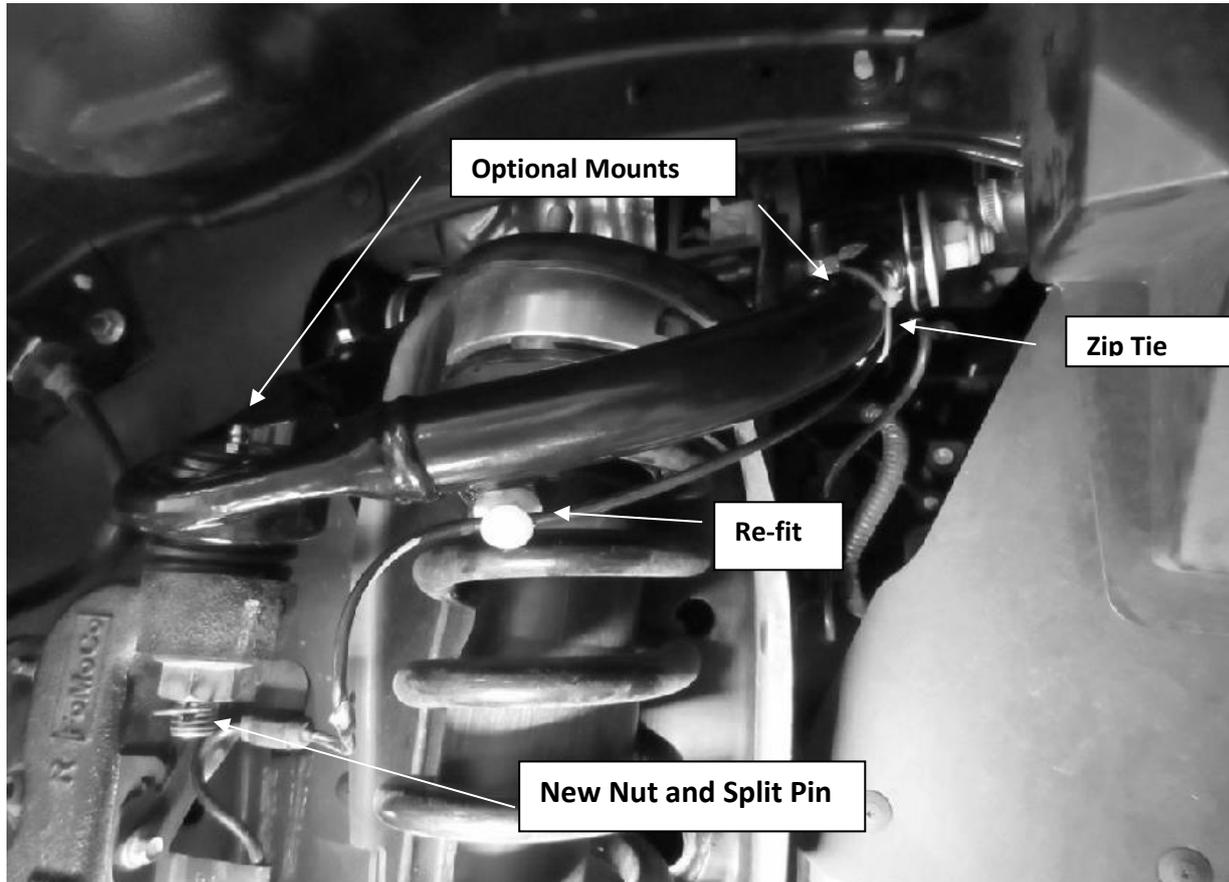
Fig 2 Reassembly

8. Using supplied grease, lightly coat the ends of the bushing.
9. Install the control arm to the vehicle using the OE bolt and washers and torque bolt-nut to 115 Nm.

10. Insert the ball joint stud into the spindle, install the newly supplied castle nut and torque to 110Nm. Tighten further until the supplied split pin can be installed.
11. Re-attach the ABS wiring bracket to the arm using the front mount, optional mounts and supplied zip tie as required. (See Figure 2)

Note: Check the length of the ABS cable, **ensure the cable isn't taugt**
