Fitting Instructions #5293IS

Jeep Cherokee KL (2014-On)

Control Arm Lower Inner Bush Kit

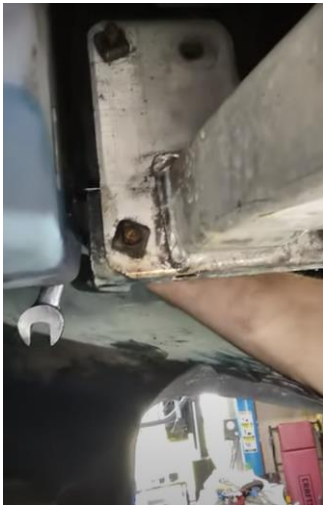
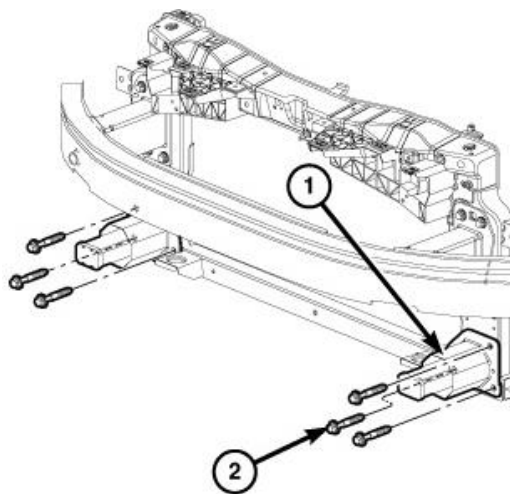
- Remove front bumper clip to gain access to the load beam bolts and extensions. Use a swivel head ratchet to undo the bolts.

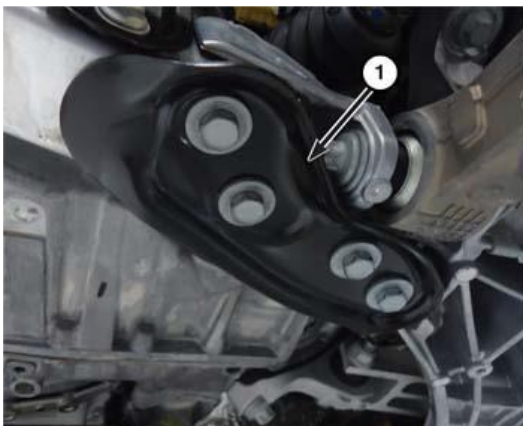
- Remove the bolts and the lower load beam bracket

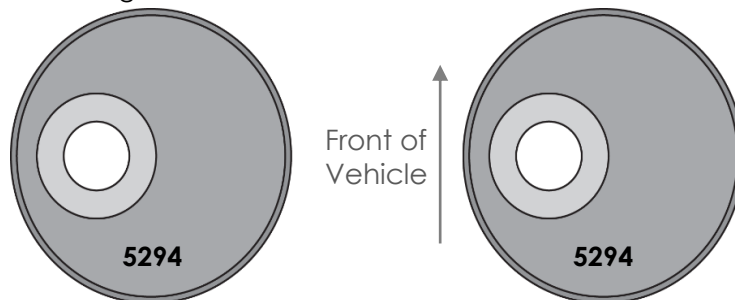
Kit SPF5294K – To counteract a strong pull left
Passenger's side castor increase and driver's side castor decrease

Table 01 – Castor Settings - As viewed from the top of the control arm.
