# FITTING INSTRUCTIONS

## DUAL CAB CENTRAL LOCKING CANOPY

**Ascent Canopy AC16C– to suit Ford Ranger Dual Cab 2022+  
(2022 Vehicle Production Onwards. Fits XL,XLS,XLT, Wildtrack, Raptor)**

**FITTING KIT: TAILGATE AND HEAD BOARD KIT 6177780. TUB MOUNT KIT 6177931**

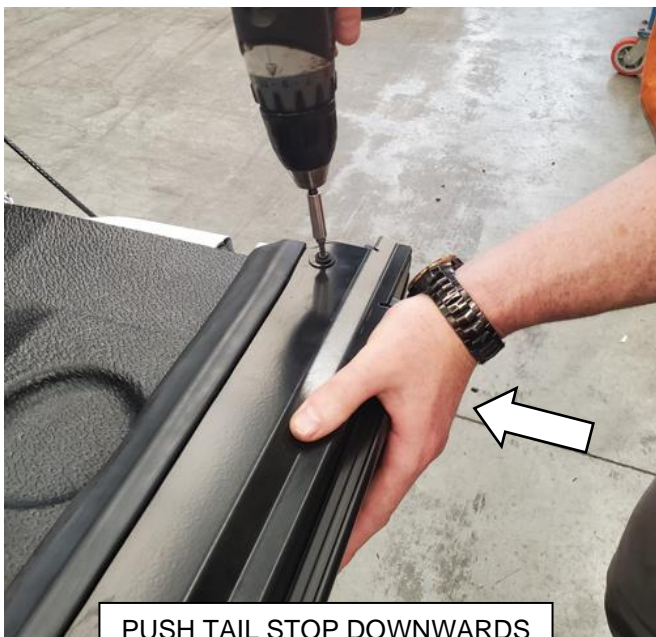
FINGER TIGHTEN TO START THREAD

PUSH TAIL STOP DOWNWARDS WHILE TIGHTENING SCREWS

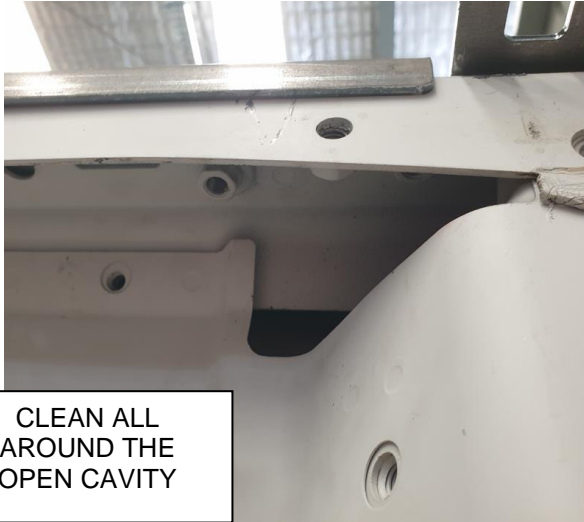
3.1) Locate the open cavity under the upper front left-hand corner of the tub and clean with an alcohol wipe (6602018).

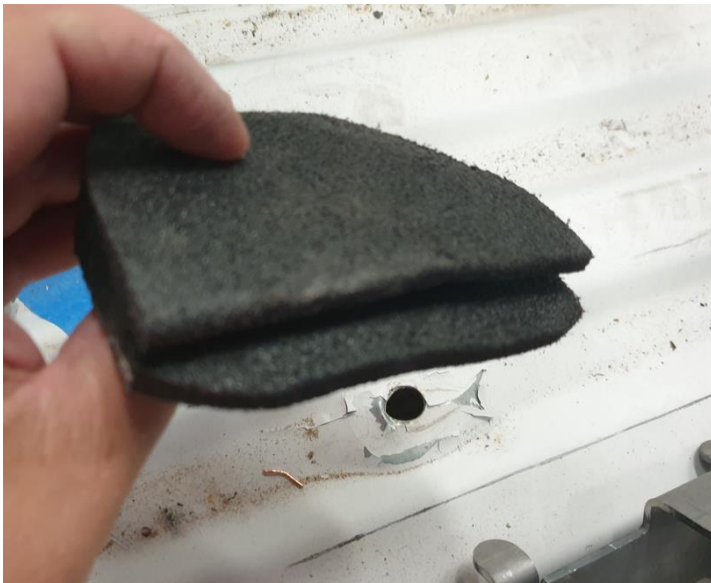
3.2) Take the left-hand foam block as per opposite from the pair of 668PB033.

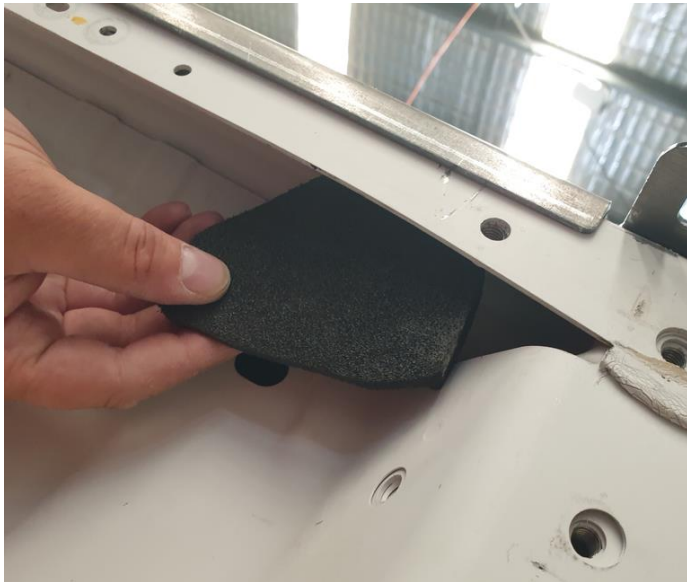
3.3) With the grooved recess edge facing down, push the foam block up into cavity opening with recessed edge, with its short leg side to clip over the tub sheet metal edge on the front pillar cavity of the tub.

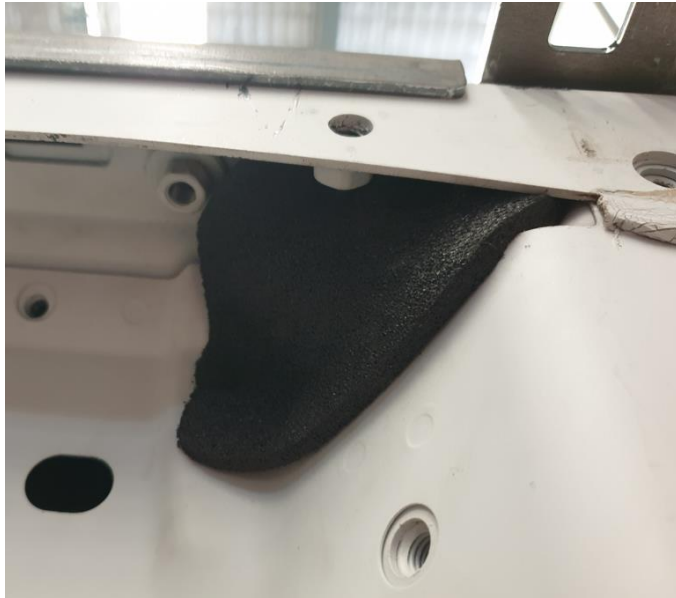
3.4) The foam sealing block is to be an interference fit with the underside of the side tub rail and fit firmly in place as shown. Position the top edge of the foam block to avoid covering weld nuts in the tub.

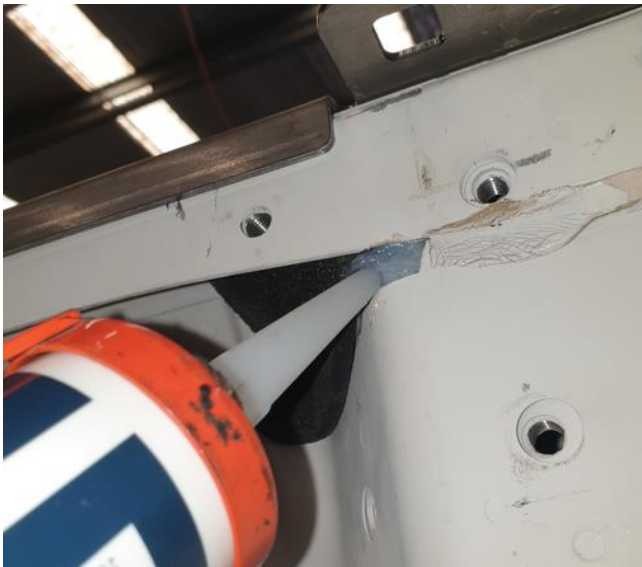
3.5) Use neutral cure non-acetic silicon to fill gaps and seal edges all around foam block and tub.

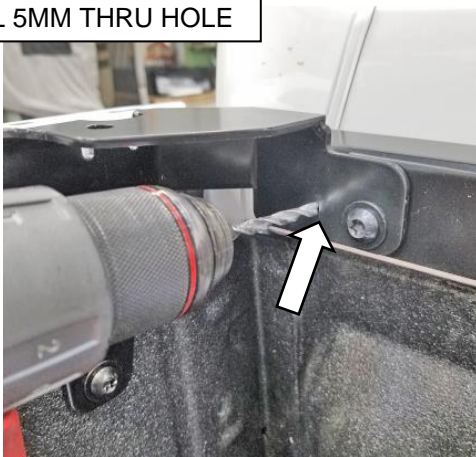
- 4.14) Drill a 5.2mm hole through the existing hole in front corner mounting bracket where it meets the front tub rail and drill through the front tub rail.

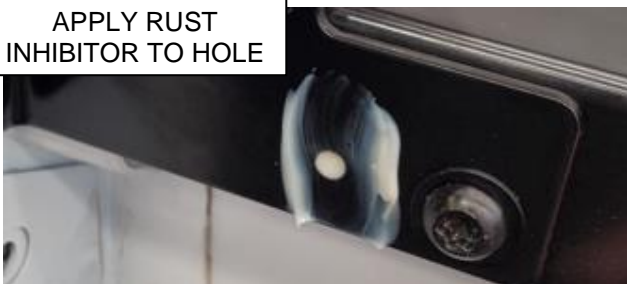
- 4.15) Apply rust inhibitor 665505 to drilled hole.

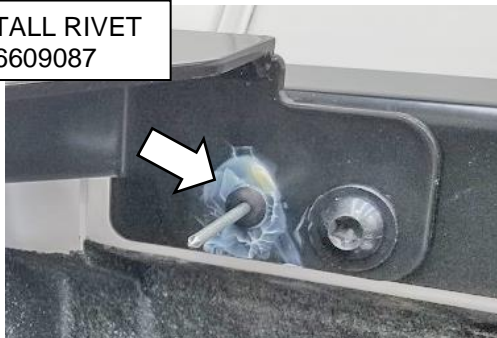
- 4.16) Install rivet (6609087) to the drilled hole.

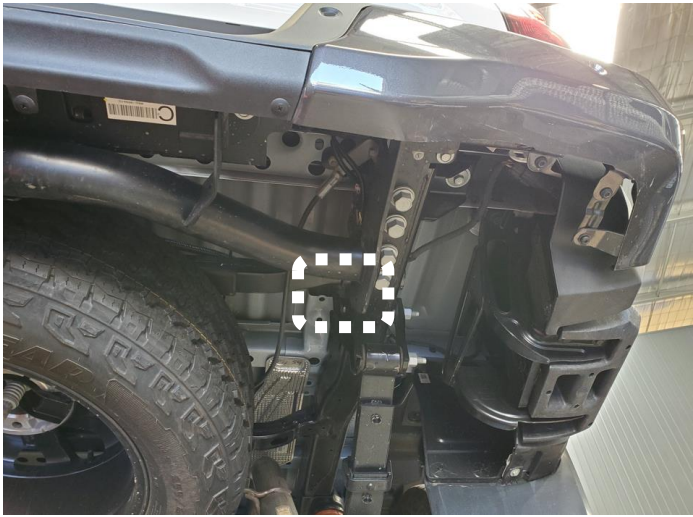
5.1) Put the car on hoist and start at the underside rear RH corner of the chassis rail.

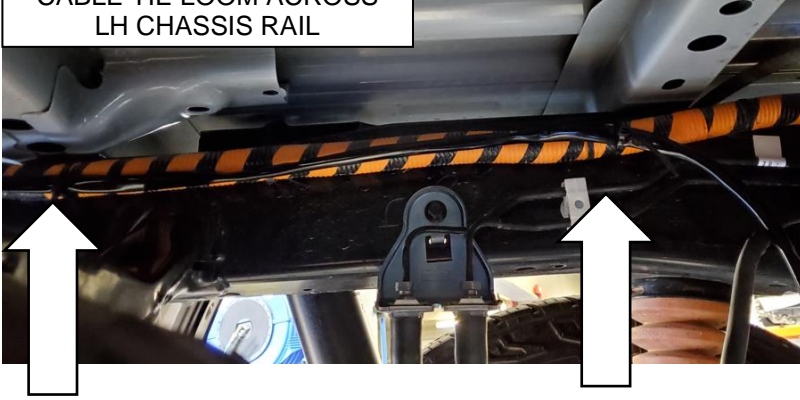
- 5.9) On inner side of LH chassis rail, locate the vehicle's wiring loom and lead the canopy loom towards the front of the vehicle and cable tie in two places rearward of the LH rear wheel bump stop.

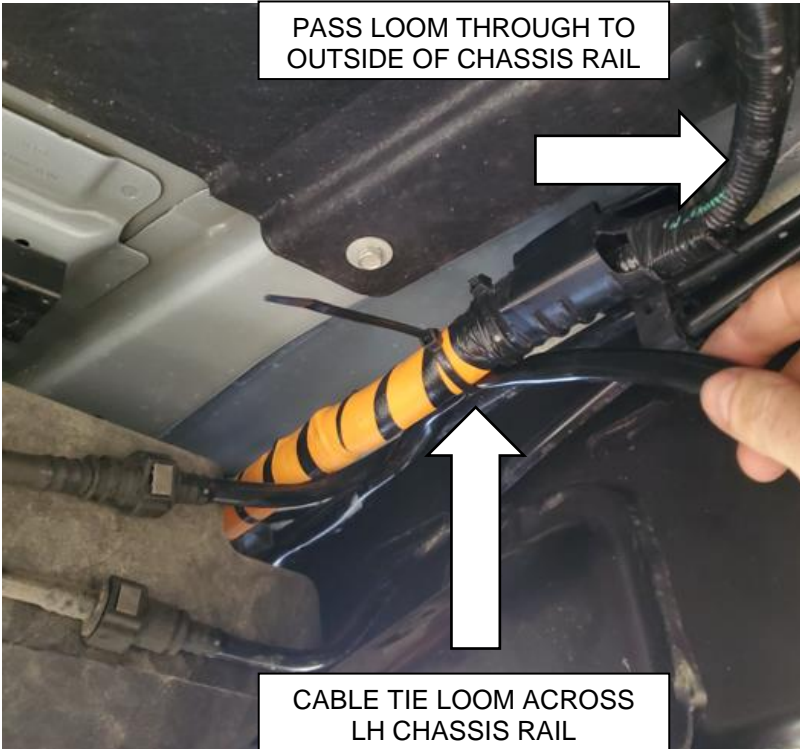
- 5.10) Cable tie off the canopy loom again at 3 places to the vehicle's wiring loom before it reaches the location where the vehicle's loom crosses over the top of the LH chassis rail.

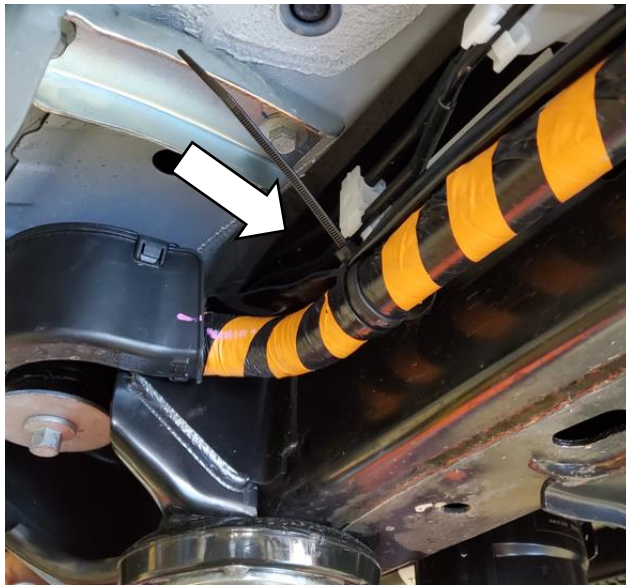
5.13) Pass the canopy loom between the chassis rail and the body floor (behind the body mount), ensuring all forward connectors and fuses are orientated to fit through the cavity.

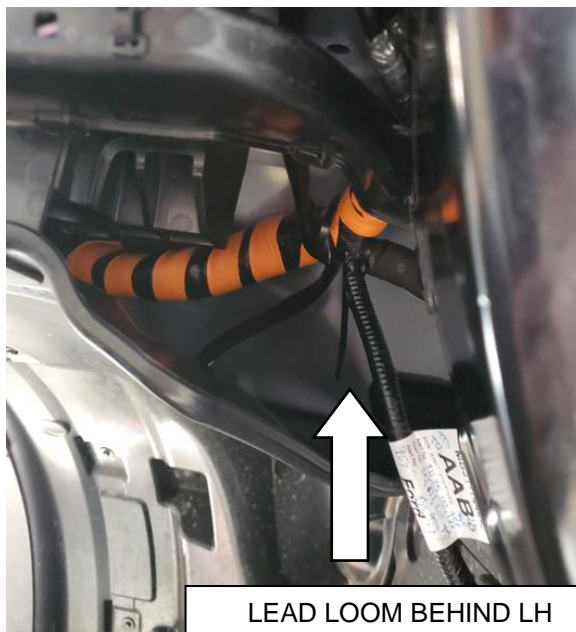
LEAD LOOM BEHIND LH FRONT WHEEL ARCH LINER

5.14) Lead the canopy loom through to the front LH front wheel arch liner and cable tie off to vehicle's main loom at the bottom

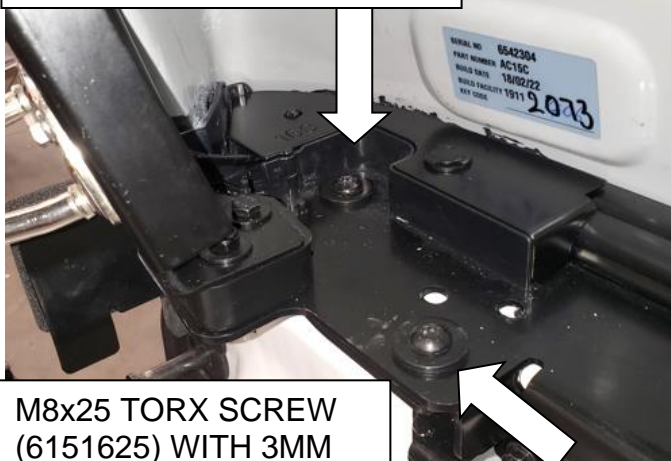
M8x35 TORX  
SCREW(6151881) WITH  
3MM THICK WASHER

M8x25 TORX SCREW  
(6151625) WITH 3MM  
THICK WASHER

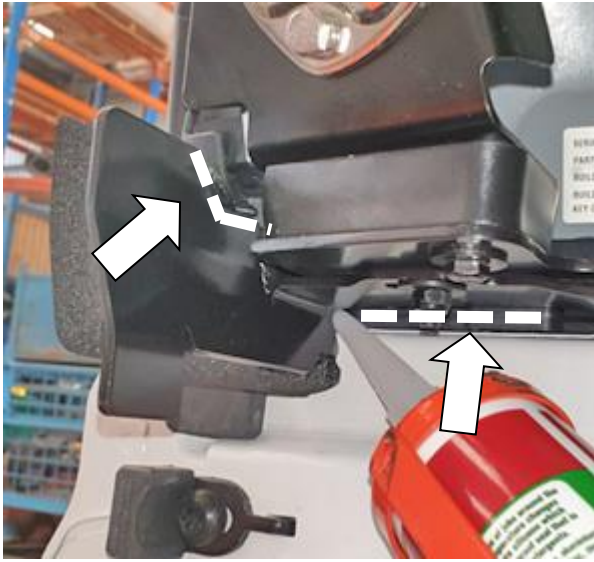
6.21) Behind the tailgate sealing bracket, between the base rail and the tub rail rear area, use neutral cure clear silicon to fill cavity at this point and also where the foam seal contacts the plastic corner piece.

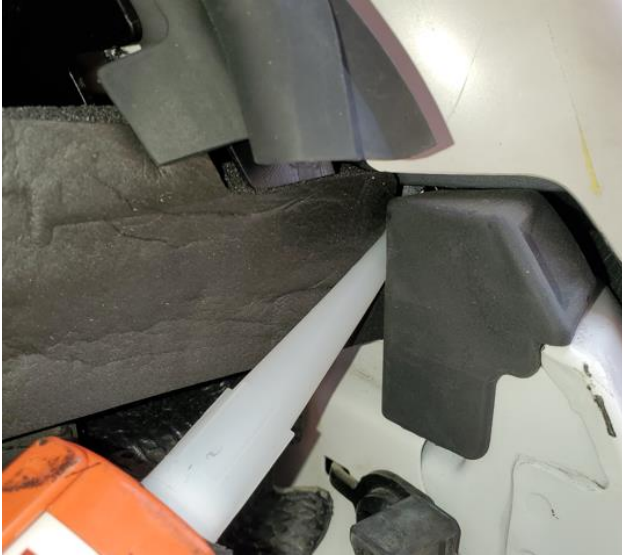
Note: Silicon is to run behind rubber corner block seal (668PE057R/L).

Clean up excess and make silicon neat.

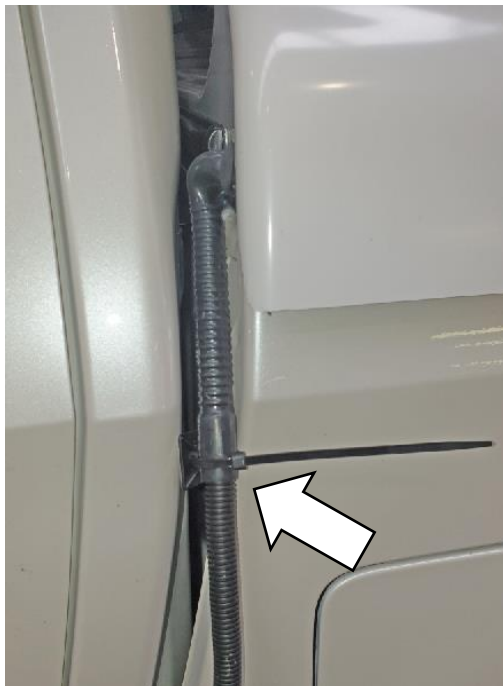
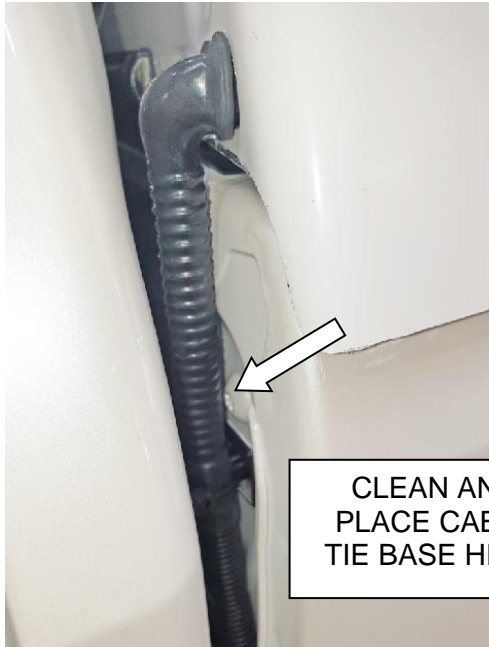
6.24) Cable tie the (6821293) cable tie base to the canopy loom at the front LH outer corner of the canopy, in the location shown (on the base of the rubber grommet) tight enough to not allow it to fall down the loom and in the orientation shown.

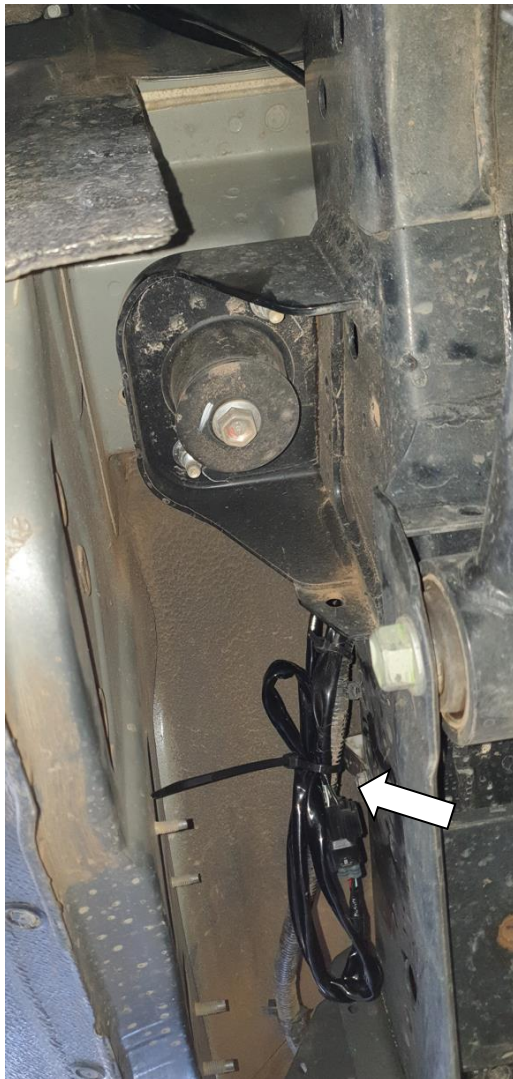
6.28) Connect the canopy wiring connector to the end connector of the canopy wiring harness (668PJ031) fitted to the vehicle, in the plenum above the LH chassis rail forwards of the LH rear cabin body mount.

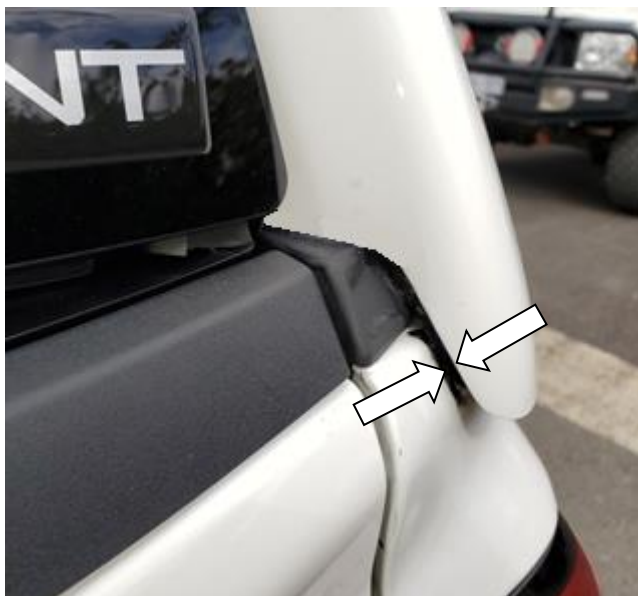
6.35) Check the gap of the canopy shell's trim edge corners to the tub. It should be even on both sides of the canopy.

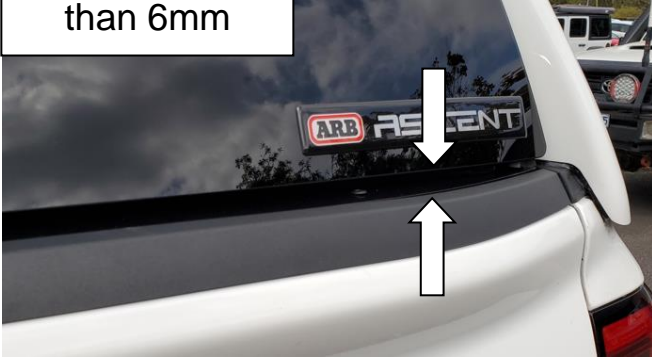
6.36) Position the canopy so the lower rear door glass edge's sash seal is sealing well and evenly along its length to the tailgate door stop extrusion assembly mounted on the tailgate. **Measure with a ruler vertically between the door glass lower edge to the top of the tailgate tub stop bracket. (This distance must not be less than 6mm and should be even). 9mm is nominal condition.**

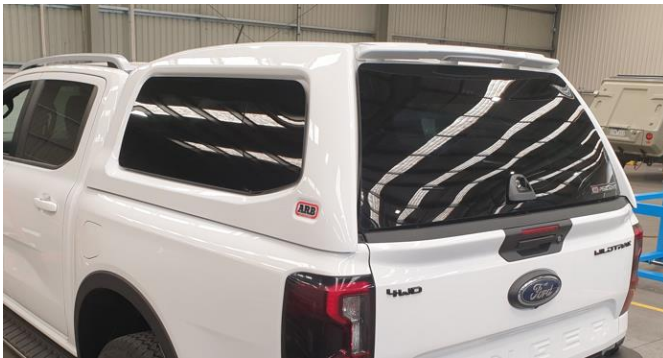
6.37) Water test the canopy around all windows and joins to the tub with high pressure hose and seal or report any leaks found.

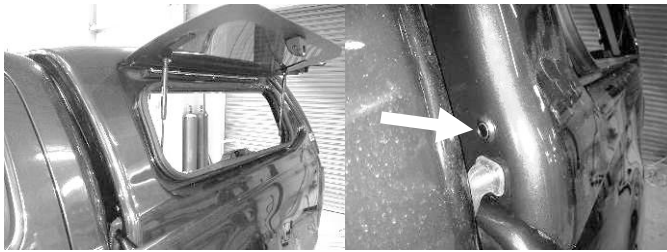
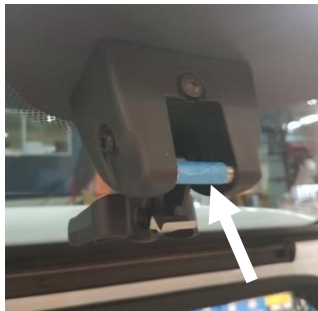
- Place one thickness of masking tape around the striker bar where the latches contact. Open and close the door. If the tape shown signs of wear through on the top side or underneath of the striker bar, it is necessary to adjust the striker away from the side on which the wear is shown. **The aim is only to have wear on the outward face of the striker bar.**
- Undo the M6 screws slightly on the strikers and adjust their position slightly. **Re-torque screws to 9Nm.**
- Test the door again and adjust via the above methods until satisfied.
