**Application -** Ford Focus ST - 2021-on

Contents - Low compliance vertical axis bushings x2

## Instructions Front Control Arm - Rear Bushing

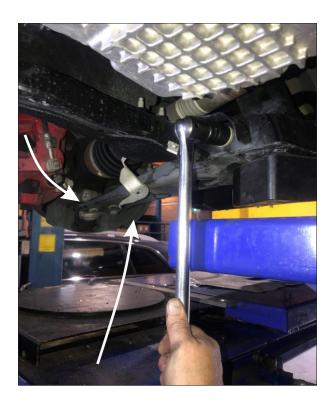
- Un-bolt front bushing bolt, also rear vertical bushing bolt. CAREFUL of ride-height sensor bracket (above).
- Proceed to press out old factory bushings.
   Refer LH image (Hydraulic Press required)

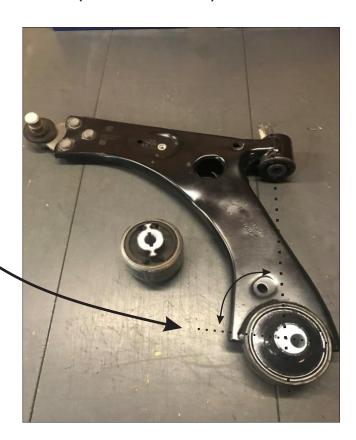
IMPORTANT - for caster improvement bushing - note offset position in RH image.

Place offset approx. 90 degrees to the front bushing axis - with bolt hole closest to engine (middle of car)
