Instructions

Rear Panhard Rod - Connecting Rod Bushings

Application - Nissan Elgrand
- E50 1995-2002

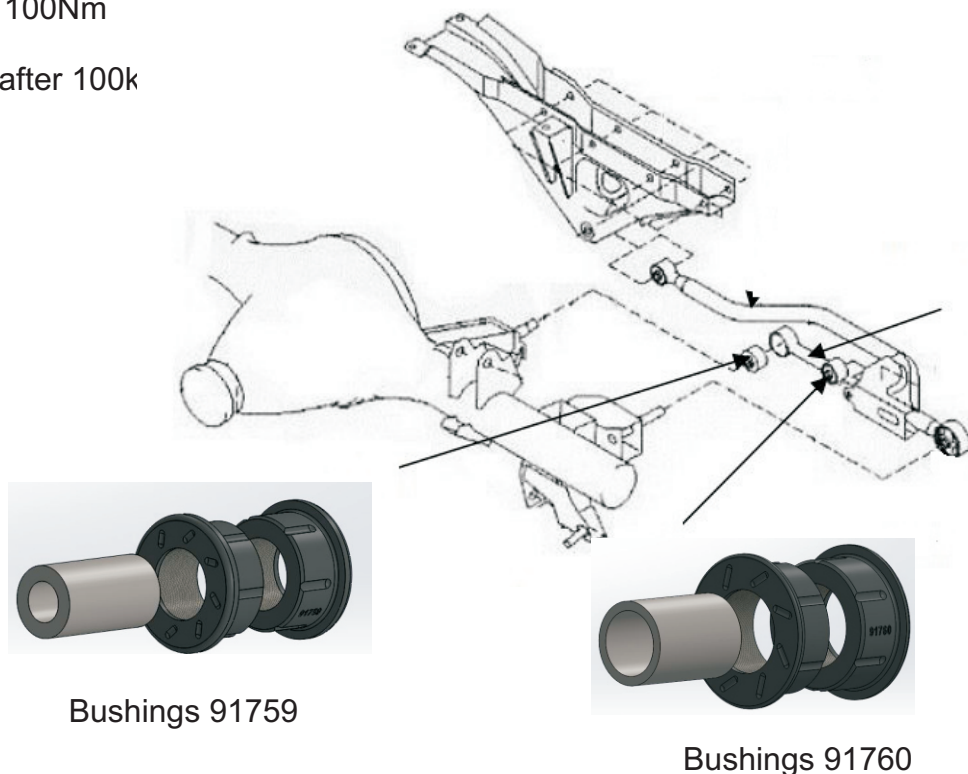
- Proceed to un-bolt connecting rod.
- A hydraulic Press will be required - to press out original bushing, including steel outer shell.
- Refer image below for bushing location.
- Push new supplied bushings in clean Eye's.
- Grease bushing internal diameter and side face with supplied grease only.
- Re-fit Connecting rod to vehicle.
- Tighten bolts to 100Nm
- Re-check bolts after 100k

Contents - Bushing 91759 x2
- Bushing 91760 x2
- Steel tube 28.6x22x39.5 x1
- Steel tube 25.4x14x45 x1
- Steel washer 42x14x2.5 x2
- Grease
