Fitting Instructions #0498IS

Holden Torana LH, LX, L34, A9X, UC

Steering Coupling Bushing

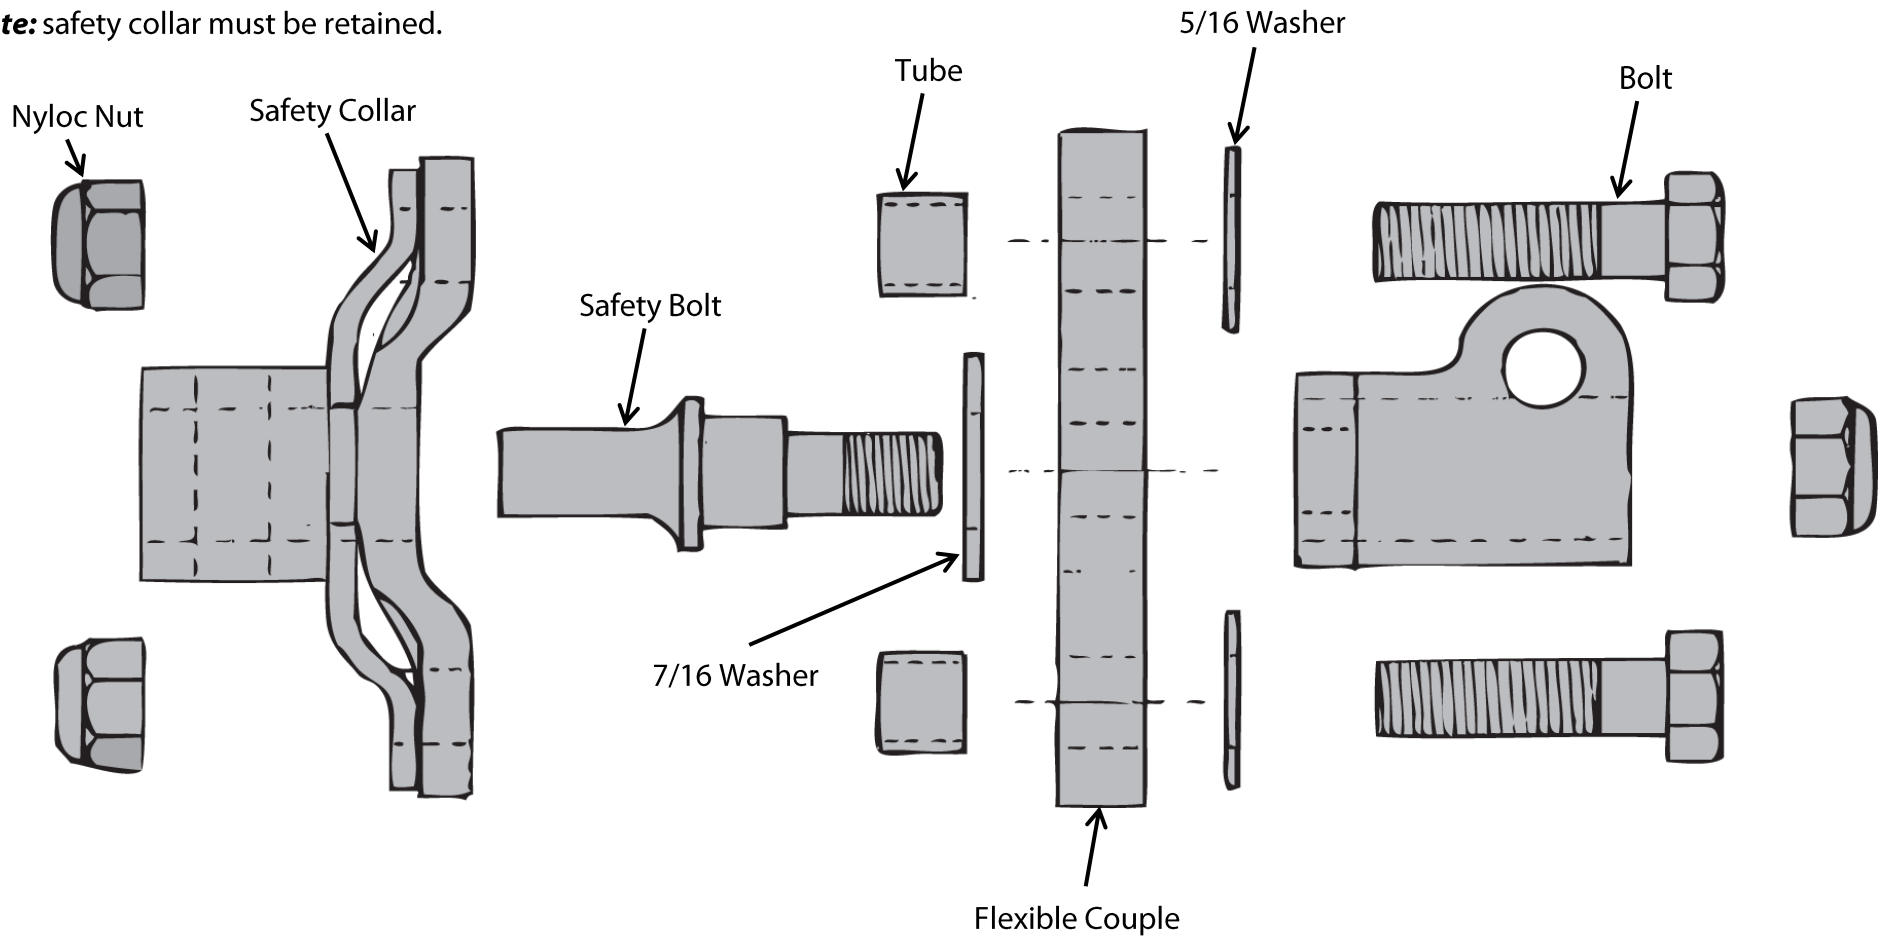
- Rivet heads to be removed with 3/8 drill after marking with centre punch;
- Use 5/16 pin punch to drive out rivets;
- Using hardware supplied, re-assemble as shown.

Note: safety collar must be retained.
