# Install Guide

## Front Upper A-Arms - Fixed Geometry Improvement

**Application** - Isuzu Dmax TF  
- Mazda Bt50 TF  
- 2020-on

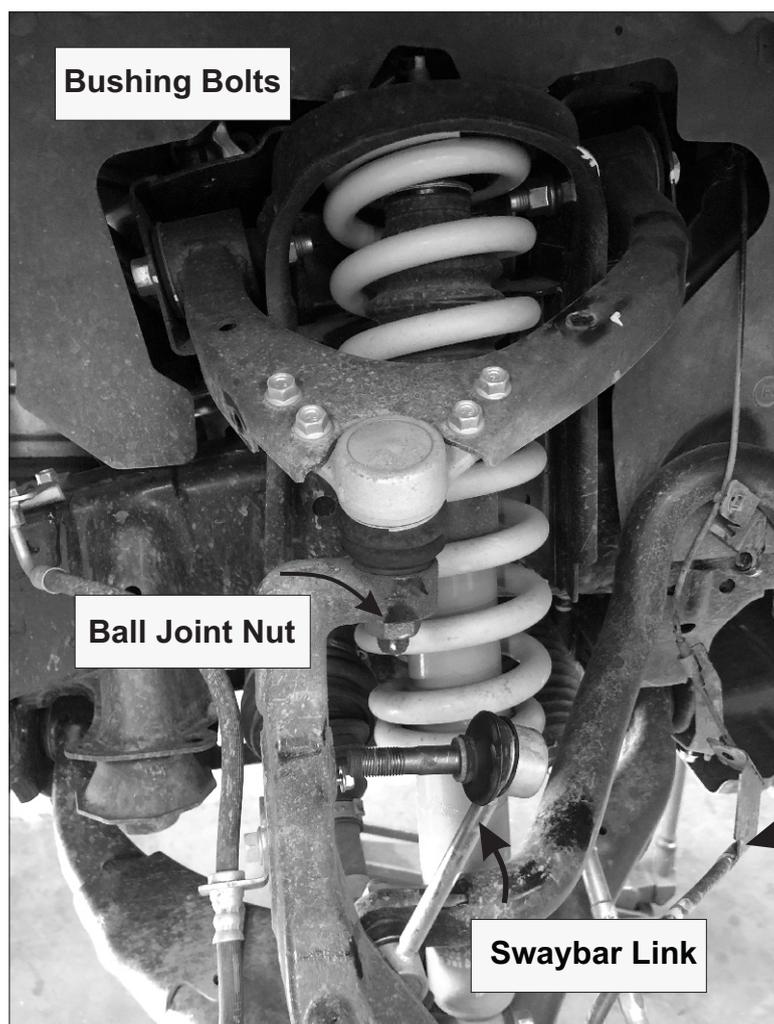
**ABS Bracket**

- Next - remove ABS wires from control arm.

There are 2 points - front and rear of arm.

**Note - the rear ABS bracket will be re-used.**

- Un-bolt swaybar link from hub - this will make the install easier.
- Remove ball joint split pin - and loosen nut. (Don't remove nut yet)
- Strike hub to break ball joint taper.
- Lastly - loosen and remove inner bushing bolts.

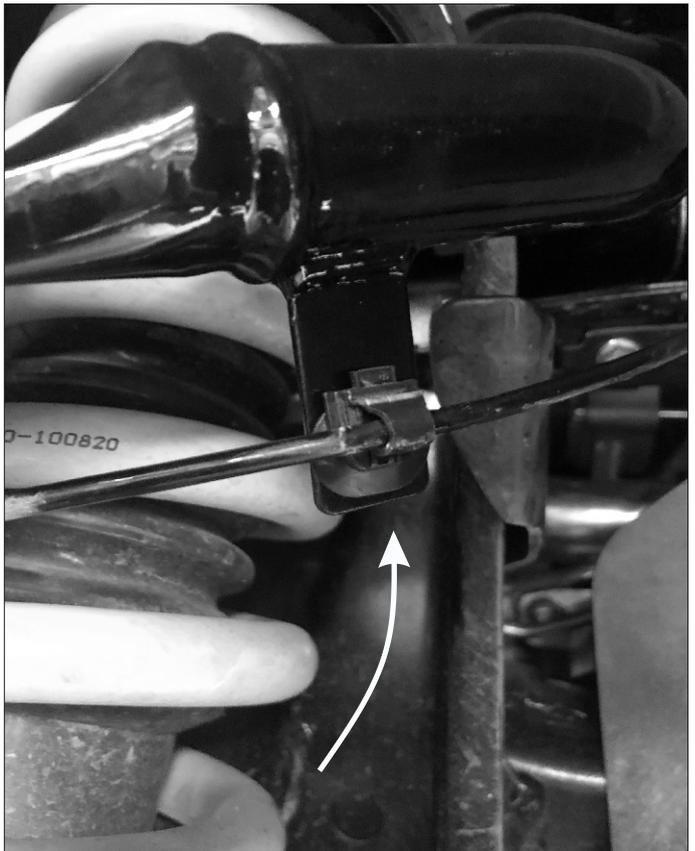
**Refer RH image**

- Proceed to bolt up new control arm to vehicle.
- Loosely start inner bushing bolts. Followed by ball joint nut.
- Pop ABS clip into front of control arm

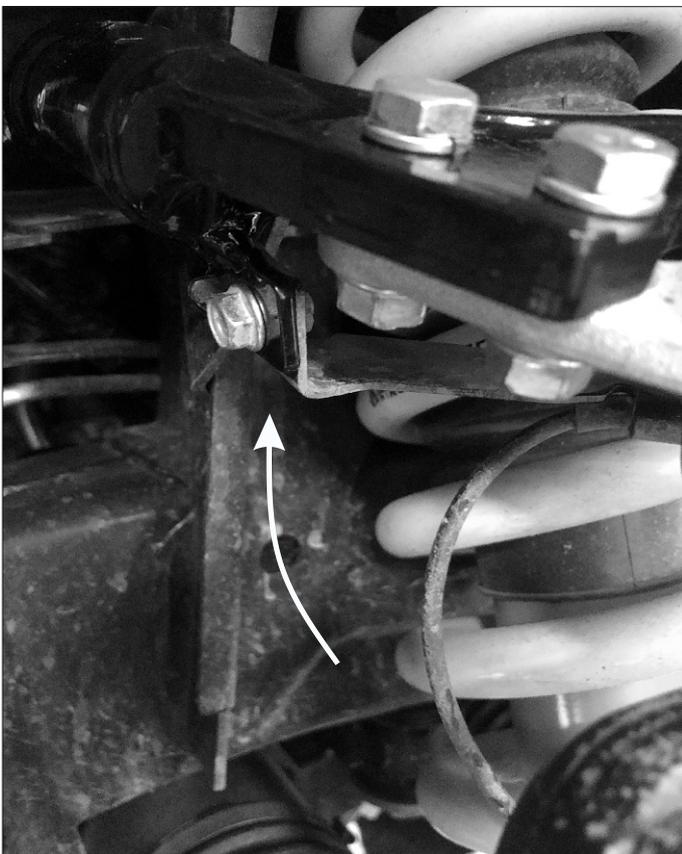
- Bolt up rear ABS bracket to rear of arm
- Refer LH image.**

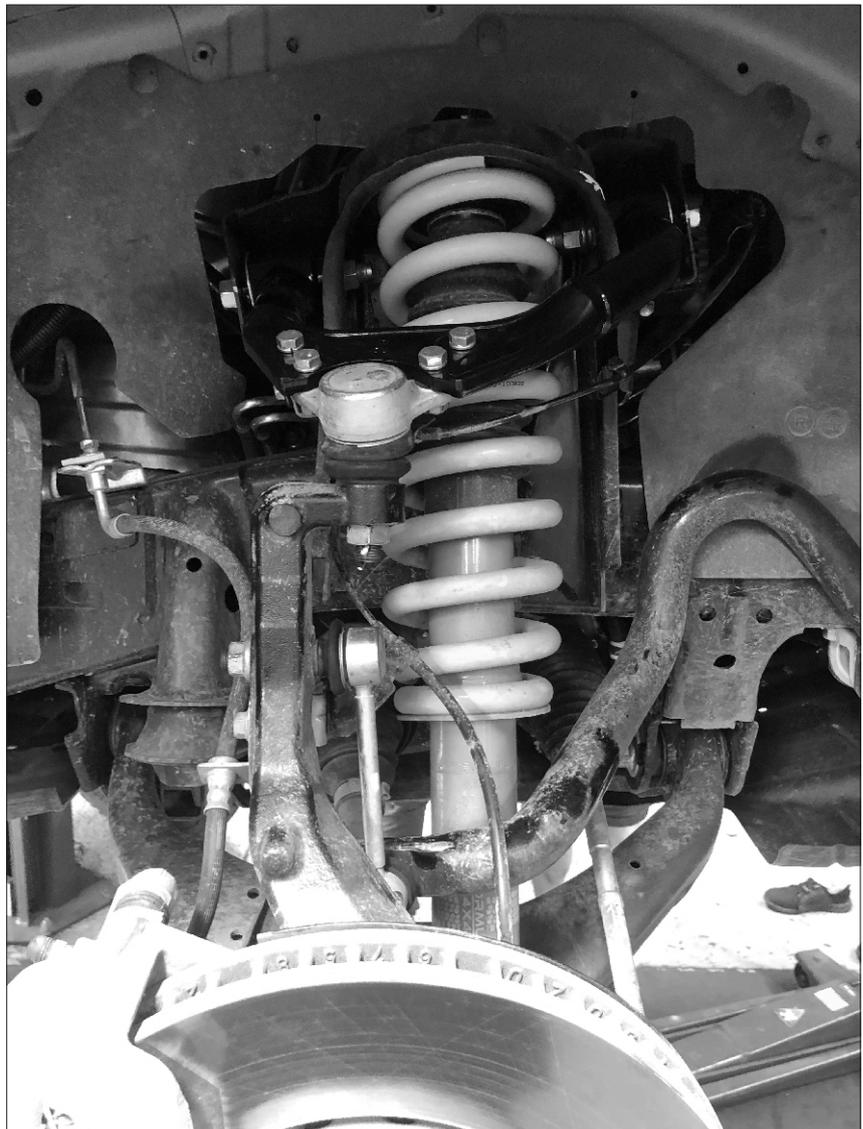
- Continue to tighten inner bushing bolts (use original factory bolts). Followed by ball joint nut.
- Also - bolt up swaybar link to hub and tighten.
- Confirm the 4 ball-joint nuts and bolts are tight - refer below.
- Check ABS wires are free and not fouling anywhere.

**Important - place new supplied split pin into ball joint stem.**

- The install is now complete and should reassemble the LH image.
