# Instructions

## Trailing Arm Bushings

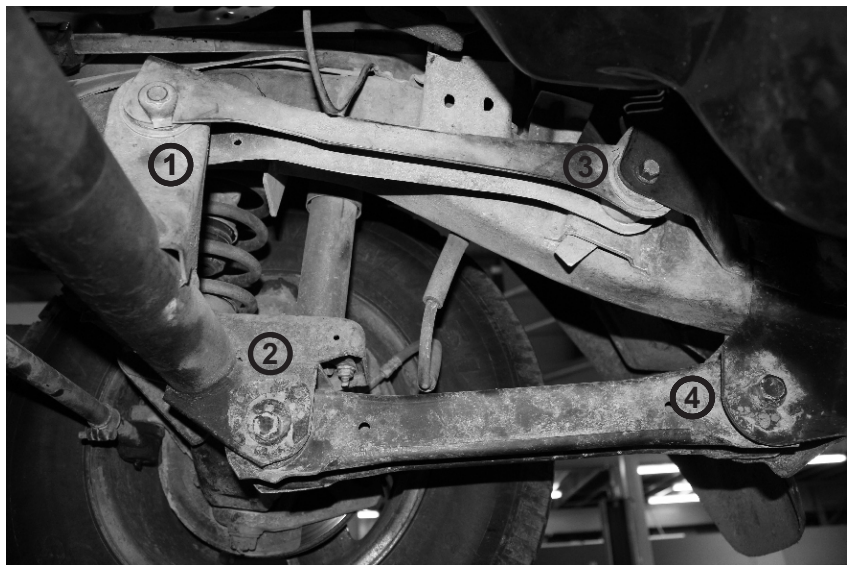
### Bushing Position

67895 - position #1 and #3  
67894

67896 - position #2  
67809

67906 - position #4  
67907

Refer image and information below regarding bushing position.  
Refer number stamped on bushing.
