# Instructions

## Front Strut Tops - Complete with Caps

**Application** - Holden Colorado RG  
- Isuzu MU-X RF

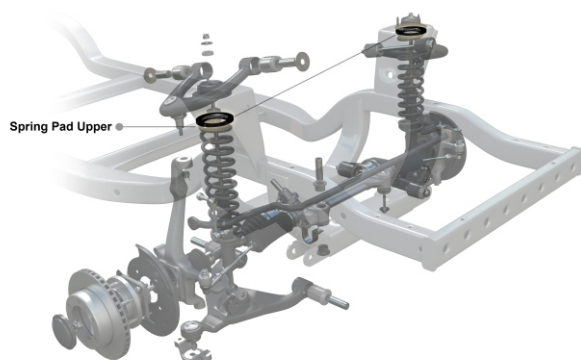
**Contents** - bushing 92004 x1  
- bushing 68201 x1  
- bushing 68202 x1  
- steel top x1  
- M10 x 1.25 nuts x3  
- flat washer 40x12x3 x2

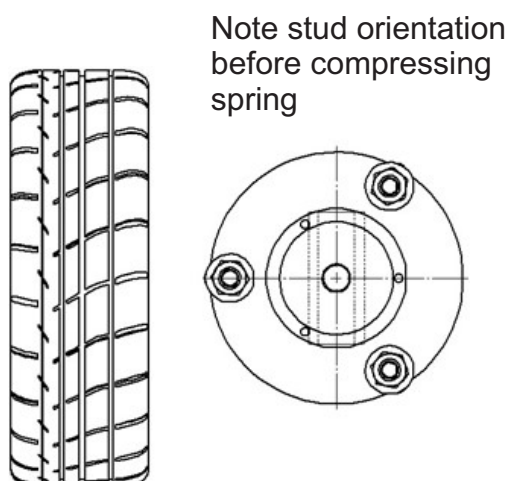
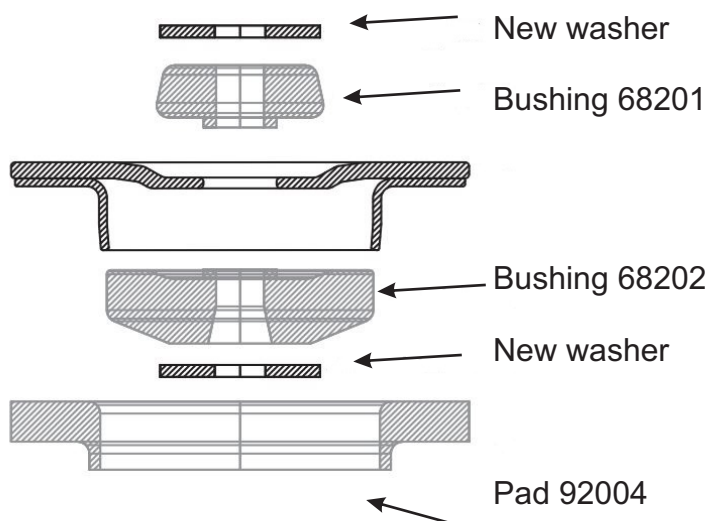
- Raise vehicle evenly and safely support.  
*Never rely on a jack only*
- Proceed to disconnect upper control arm ball joint. Complete removal of the arm may be necessary to remove the strut.
- Next, un-bolt complete strut from vehicle. Note orientation of the 3 studs verse the wheel . This will help with re-fitting strut to vehicle. Note below LH image.
- Compress the spring to remove the upper top. Fit up new top with new shock bushings and spring pad. Re-use OE upper shock nut.
